BUSCH WILDLIFE AREA LAKE NO. 35 DAM ST. CHARLES COUNTY, MISSOURI MO. 10092

PHASE I INSPECTION REPORT NATIONAL DAM SAFETY PROGRAM

NOVEMBER 1979

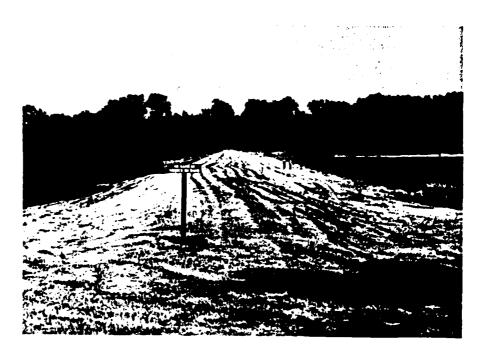
Photo 1

The crest of the dam is protected against surface erosion by a well maintained cover of grass. There was no evidence of significant settlement or cracking on the crest. No significant deviations in horizontal or vertical alignment were apparent. There was no evidence of the dam ever being overtopped.

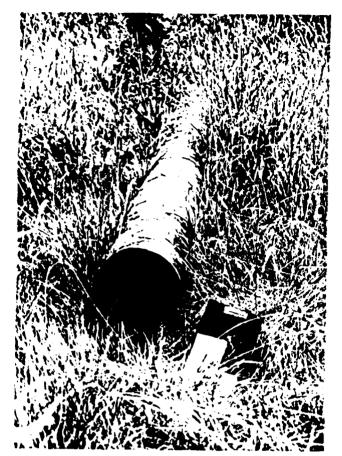
Photo 11

The outlet of the 12-inch diameter C.I.P. low level drain was observed. No seepage through or around the pipe was apparent. The inlet to the pipe was not located. The gate valve housing was located, however, the valve control could not be seen due to the debris on top of it.

The low level lake drain did not show any sign of structural instability. Nevertheless, the gate valve should be operated to determine if it is operable and verify that drain is not clogged. If the drain does not function, necessary repairs should be made in case the reservoir has to be lowered for any reason.
